## **Investigating Catastrophic Stair Falls**

*Richard Nellis and Bailey Gutkin*

### **Case Study: Unwitnessed Fall in Ascent**

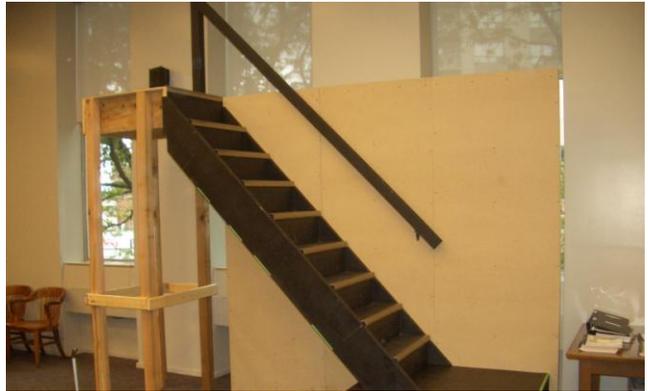
***Full-scale replica which was used as an exhibit in court.***

Origin of Cause: Many code violations were identified including riser heights that exceeded the maximum in the building code. The tread depth was also below the minimum criteria, creating a steep stair. Excessive, varied risers are unexpected and create trip hazards.

The handrail clearance was such that fingers could not maintain a continuous grasp of the handrail and did not provide sufficient support.

It was our professional opinion that the condition of the stair, specifically the excessive riser heights and variance of the risers, run and tread width throughout the stairway created an unsafe condition that contributed to the loss of balance and fall.
